RA-1 INTERIM REPORT
SPACECRAFT FLIGHT PERFORMANCE

November 2, 1961

RA-1 SPACECRAFT FLIGHT PERFORMANCE

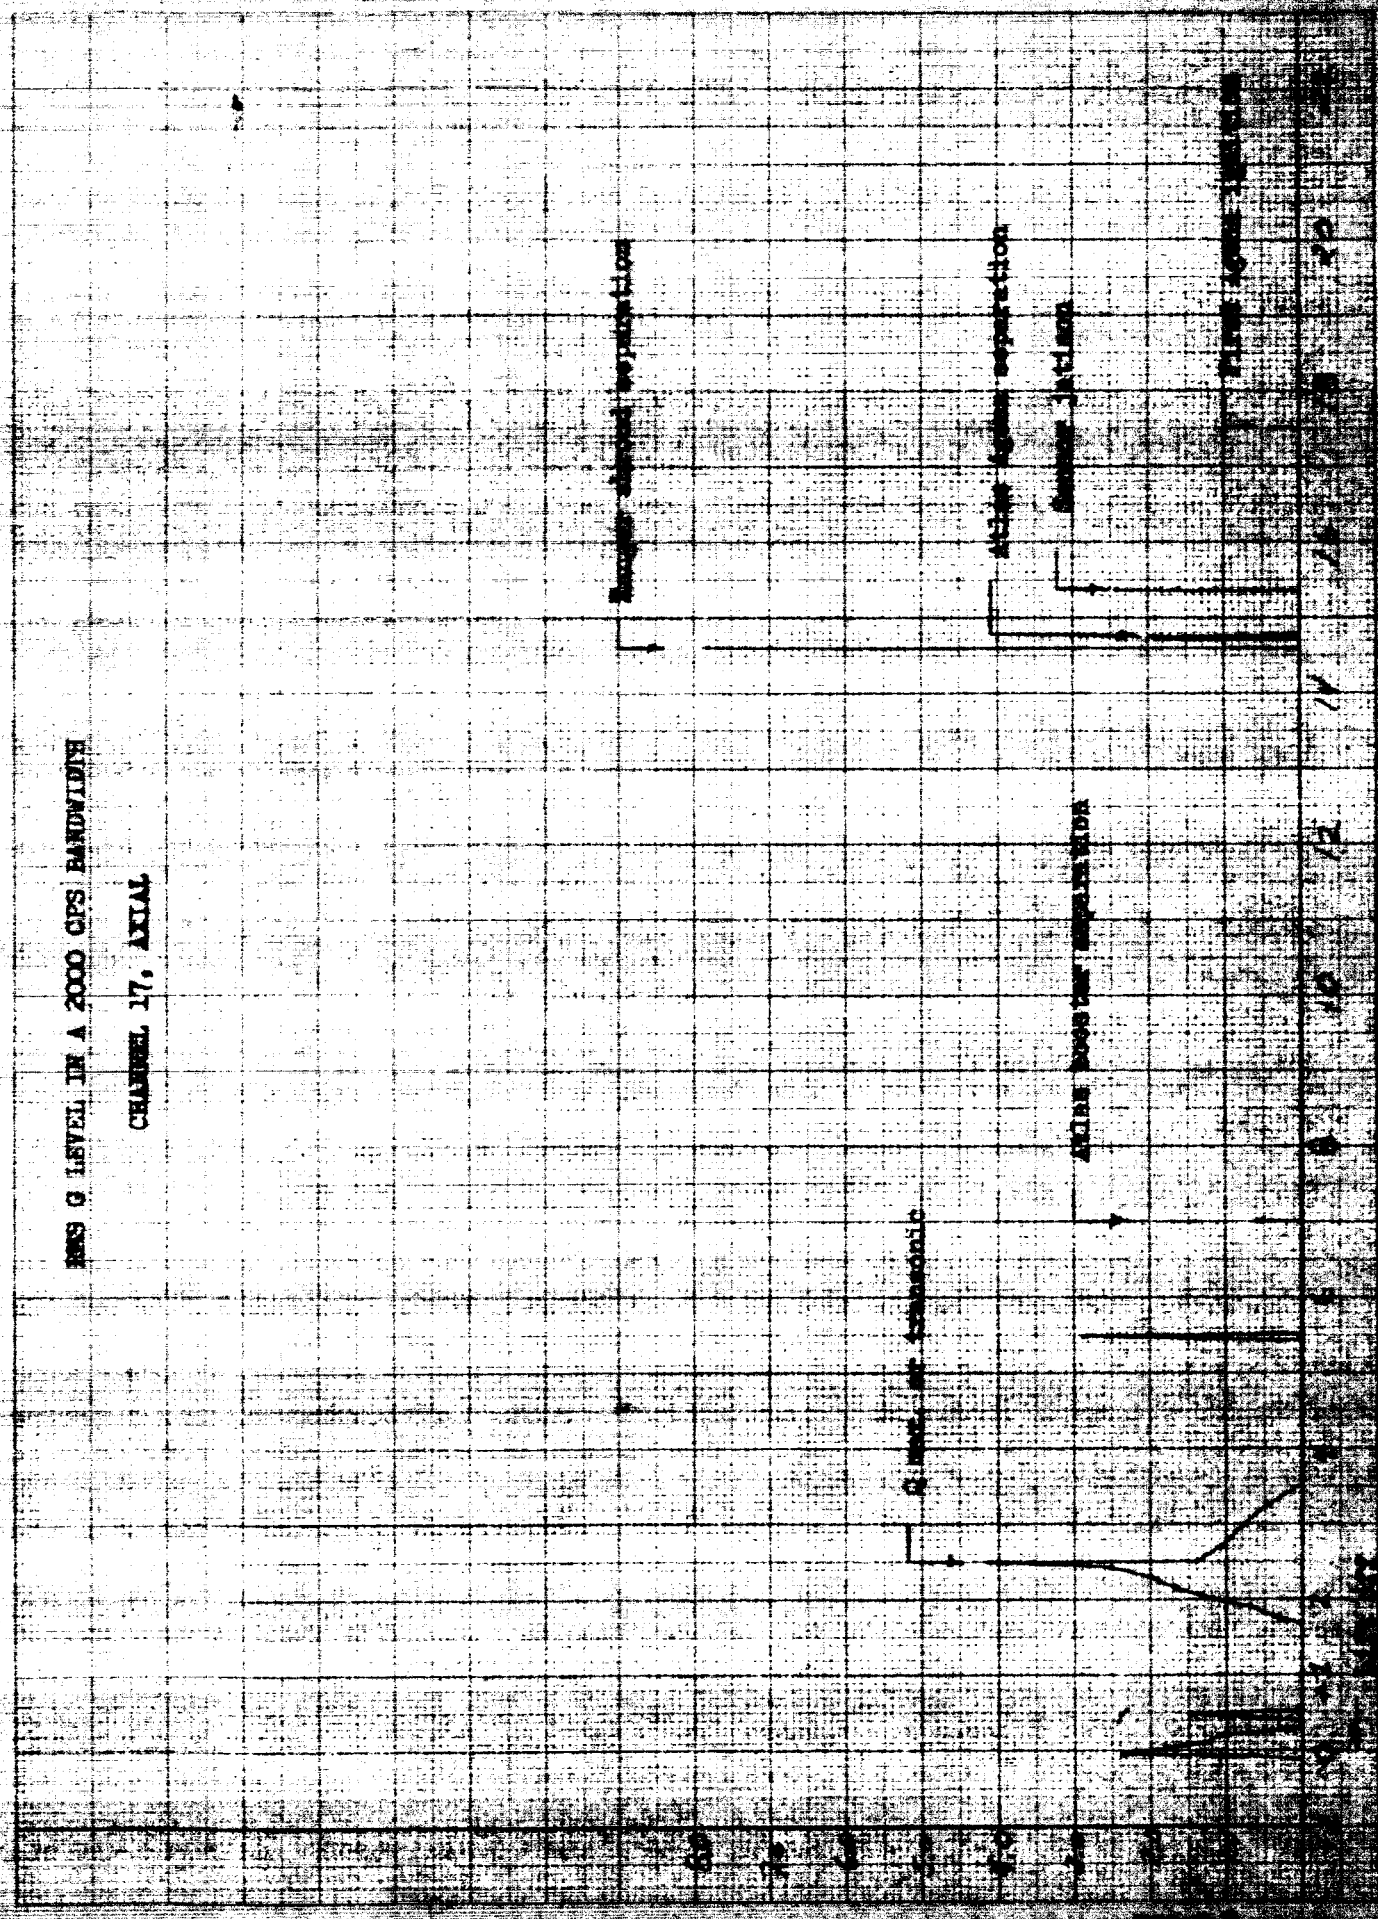
Relative Time of Flight - fig 1

The RMS g levels of Ch 17 and 18 are plotted as a function of time, in Figure 1 and 2, up to the mid-portion of 1st Agena burn. The data point marked "shroud separation" is not valid due to the type of data reduction used and should be disregarded; this data point will be discussed later under transient excitation. The maximum steady state vibration levels occurred during transonic flight shortly after lift-off (at about 19,000 ft.). The flight data from this portion of flight has been replotted from the original power spectral density plots obtained from LMSD and is represented in Figures 3 and 4 for Ch 19 and 18 respectively. The actual tape loops were taken just before the sharp g pike. In addition to the flight data on Figures 3 and 4, the predicted acoustic-free response of the S/C to the measured input and the appropriate noise portion of pertinent JPL specifications are plotted; i.e., the maximum square of the envelope of spacecraft response as measured in the environmental lab was multiplied point by point by the PSD of in-flight vibration data, thus obtaining the PSD of acoustic-free response.

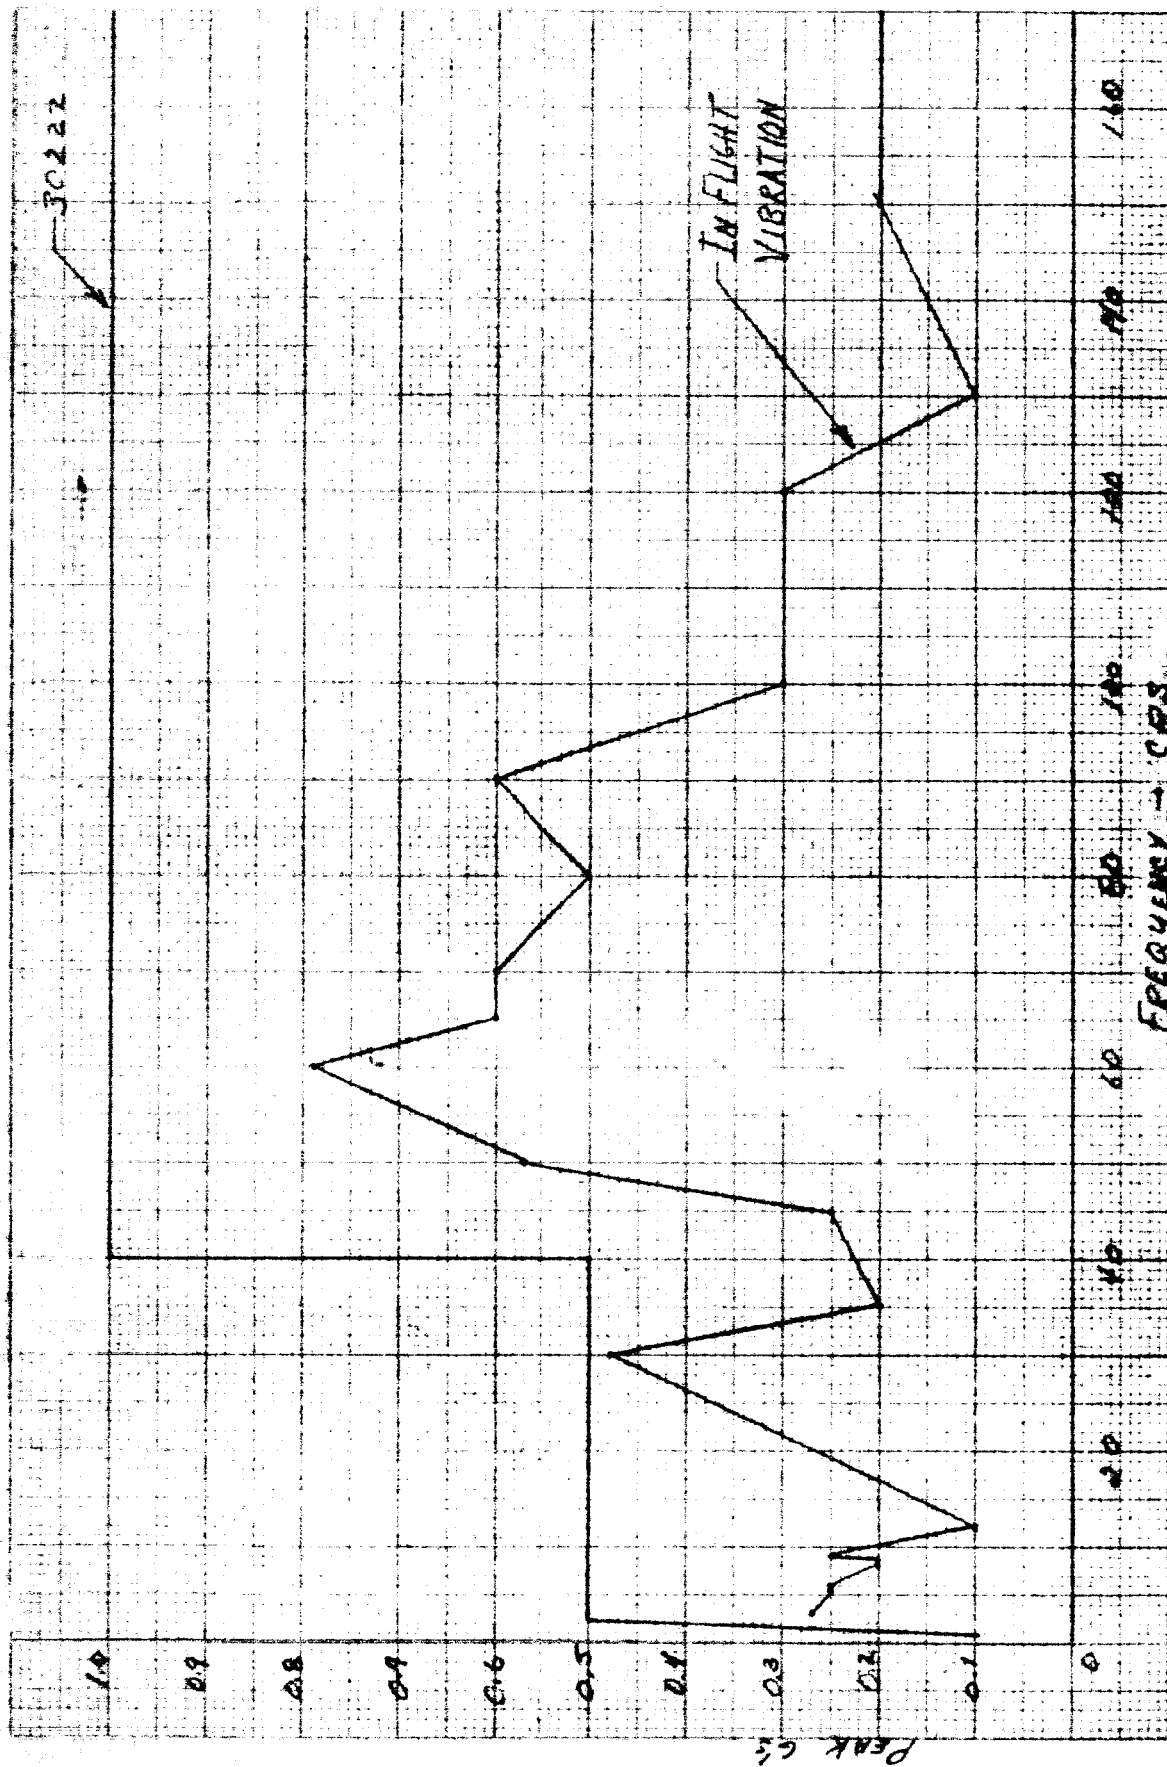
Fig. 5

The low frequency flight data from RA-1 is plotted in Figure 5. The "in-flight vibration" levels were taken from oscilograph records of Ch 10 (radial), Ch 11 (radial), and Ch 12 (lateral). The levels indicated are the maximum levels observed during flight, neglecting major transients

The comparison of low frequency flight environment for pitch and yaw with the FA test of RA-1 S/C, as depicted in Figure 5, indicates that the test was adequate. Figure 6 indicates that two or three portions of the S/C that resonate near 15 and 30 cps were inadequately tested at the assembly level. The actual levels as seen by most portions of the omni-antenna, Lyman & Screpa using the assembly spec. would be effected by a resonance gain of possibly 5 or 10. The testing of these assemblies was done in such a manner, excitation from point of attachment to spacecraft, that the vibration levels on the body of the instruments was in excess of the levels predicted here. The levels experienced by these assemblies during the S/C FA test did exceed assembly test levels and the flight environment, and, as a result, all assemblies were qualified at the assembly level and/or the S/C test level. In addition, the PTM S/C was tested to levels in excess of levels used for FA testing.

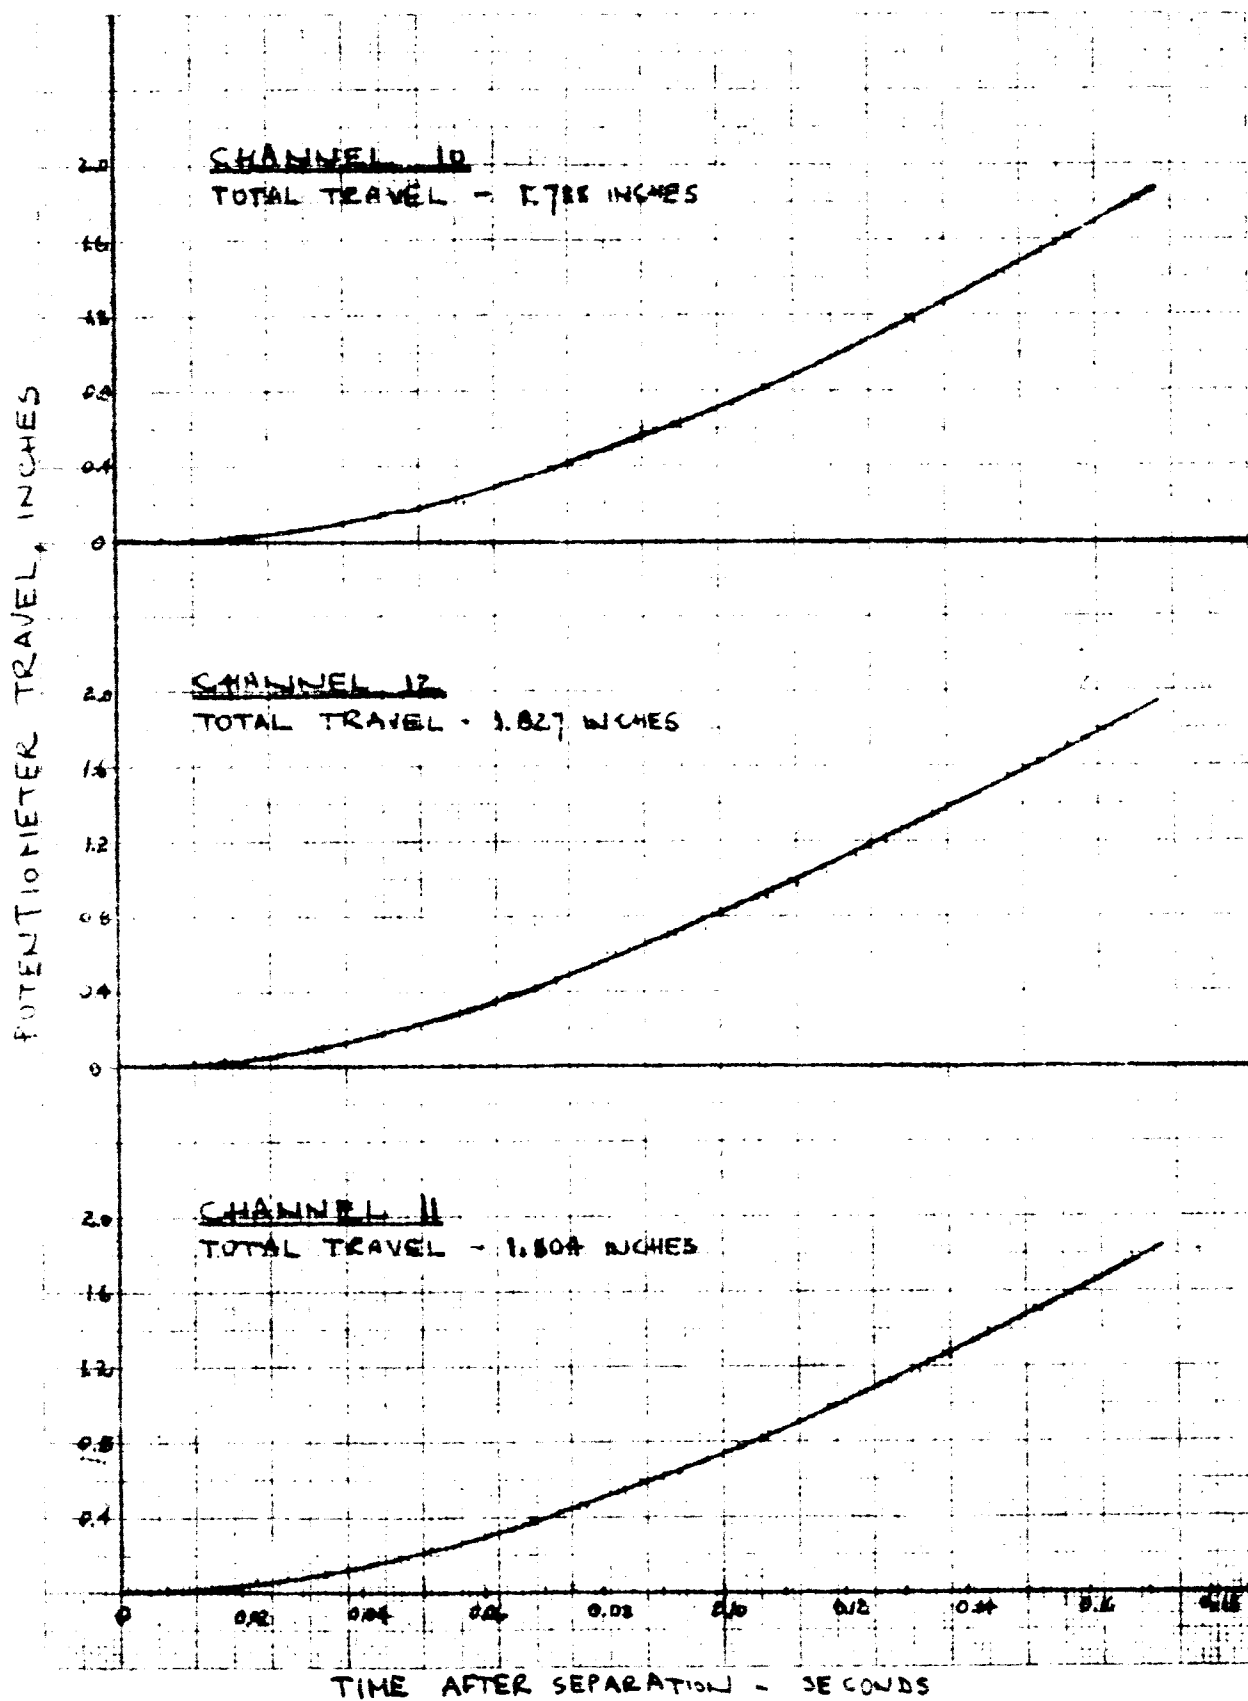
Figure A shows a displacement versus time plot for the three potentiometers. Numerical differentiation of the above data shows that the velocity of the spacecraft relative to the Agena at the end of potentiometer travel was 1.5 fps.

The difference in the displacement readouts of the three potentiometers at any time was on the order of the accuracy of the instrumentation, so no exact pitch or yaw rates could be derived from the above data. It can be concluded, however, that the rates were less than the specified $3^{\circ}/\text{sec}$ and that the separation was smooth.

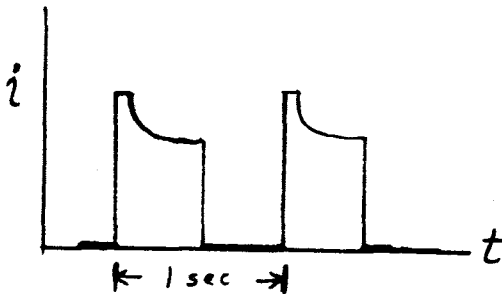
Figure a. Light Overload

2. The interrogation pulse wave form varied as a function of overload, advancing rapidly from that shown in Figure a. for very light overloads to that of Figure b. for moderate and heavy overloads.

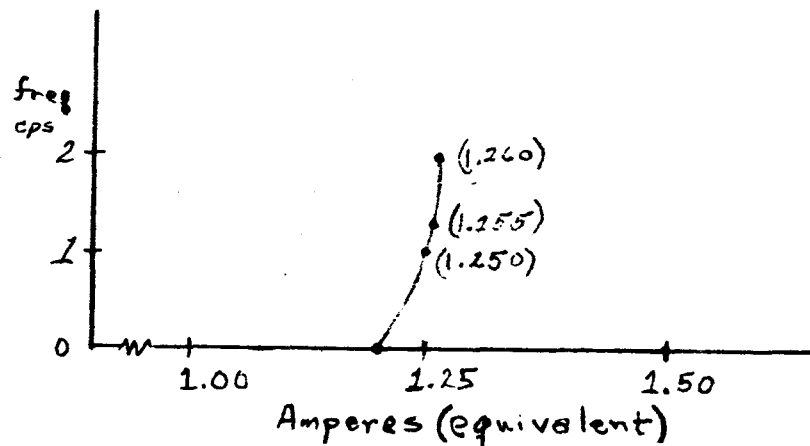
3. As indicated above the interrogation frequency also changed as a function of load from approximately 1 cps to 2 cps. A plot of this is shown below.

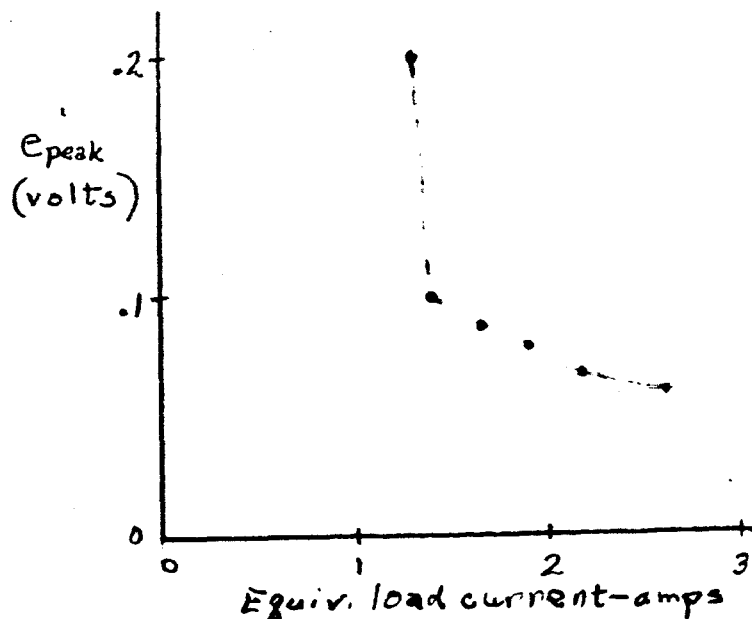
Figure a.

Test E. Since the interrogation pulses were observed on flight telemetry data of the rate gyro outputs, similar observations were made in the laboratory to determine if an indication of line current could be obtained from pulse amplitudes as observed at the rate gyro outputs. For this test the gyros were torqued at maximum rate and the output wave form and amplitude was noted. Curves of these are shown below.

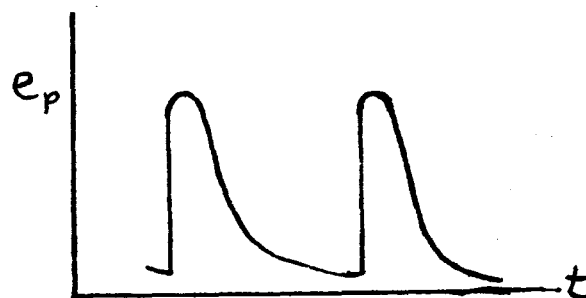
Figure b.

This data has not yet been compared with flight results
